## **The Effect of Earthquake and Volcanic Eruption to the Nuclear Installation: A Retrospective on 2006 Yogyakarta Earthquake and Merapi Eruption**

Mochammad Yazid<sup>1\*</sup>, Khoiria Nur Atika Putri<sup>2</sup>

<sup>1</sup>Center for Accelerator Science and Technology.  
National Nuclear Agency, Yogyakarta, Indonesia

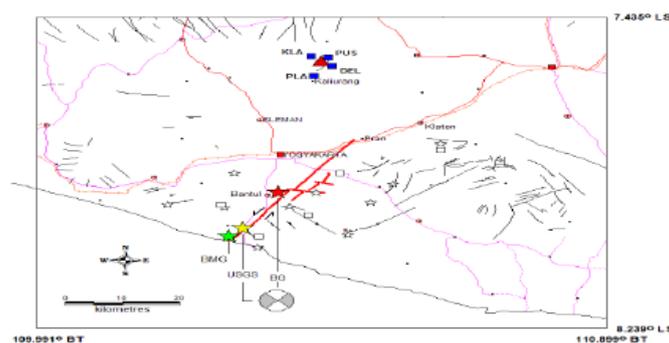
Based on the analysis of the focal mechanism issued by the USGS, the type of fault that caused the earthquake was the sinistral strike slip fault and the geological map issued by the Geological Survey Center (formerly the Geological Research and Development Center) of the ESDM Geological Agency, it can be concluded The cause of the earthquake was due to active fault activity in the southern part of Yogyakarta in a southwest-northeast direction with a position of N 231o E, Dip 87° and slip 3°, as shown on the map in **Figure 1**.

**Figure 1.** Calculation of the epicenter of the Yogyakarta earthquake according to BMKG, USGS and BG. [2]

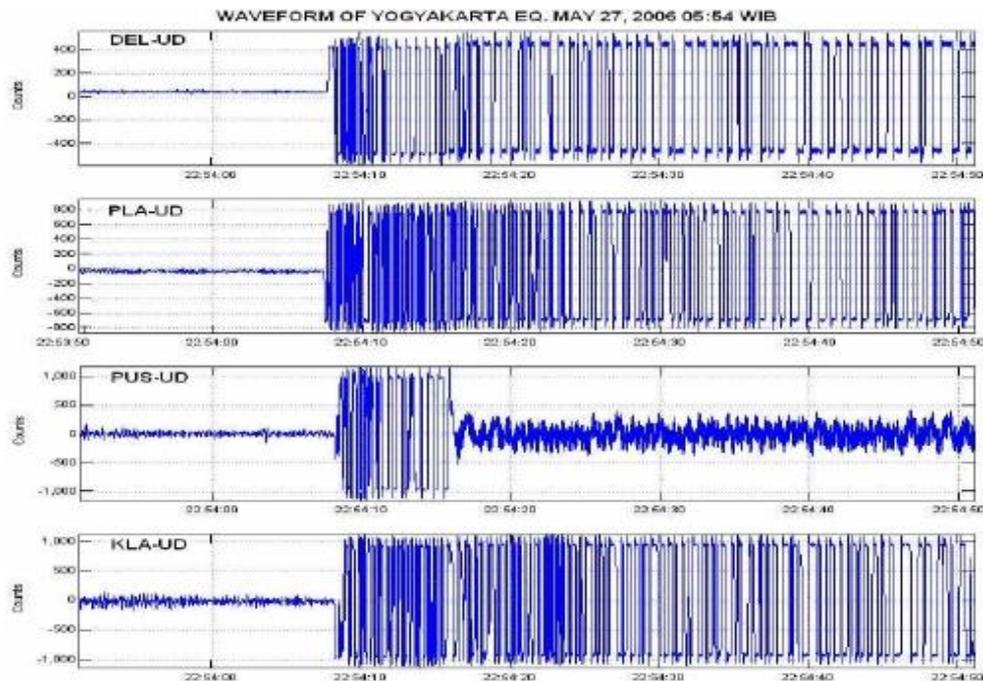
**Figure 2.** Seismogram of the Yogyakarta earthquake from BPPTK

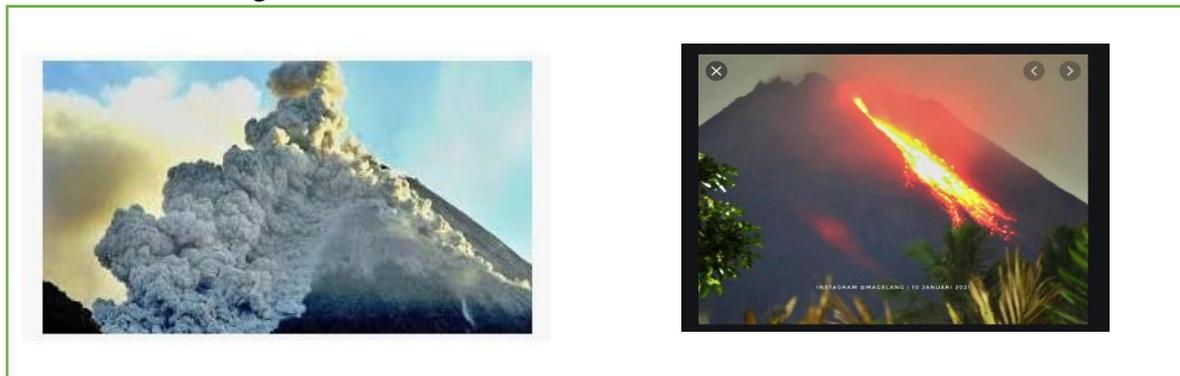
**Figure 3.** Merapi volcano eruption and the release of hot clouds and lava incandescent

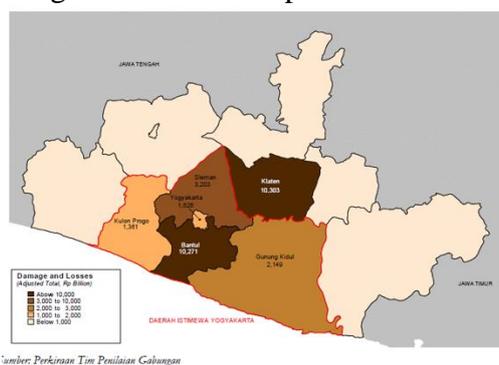
**Figure 4.** Geographical Damage Distribution Map

Based on Figure 4, the impact that was highly concentrated in the districts of Bantul, Yogyakarta Province and Klaten in Central Java. Bantul and Klaten together suffered more than 70% of all damage and losses. Among the other main areas that suffered damage included Yogyakarta City and three other rural districts in Yogyakarta province as shown on the map in Figure 4. Klaten district experienced the most damage, particularly housing, while in Bantul the damage and losses were severe in the productive and housing sectors [4].
